# Manhole Inspection Summary

Manhole # S53I\_\_030MH

Insp Date: **9/16/09 8:56 AM**

**Location** Address: **behind 3031 Eastern Ave.**

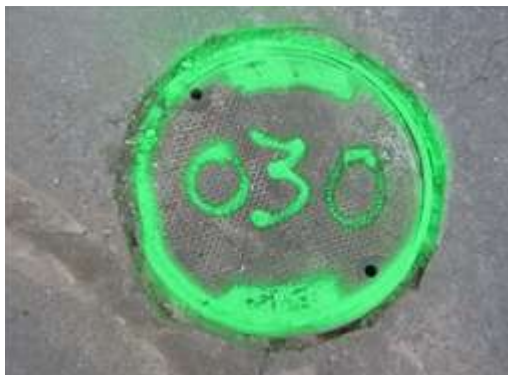
Miscellaneous

MH Lid

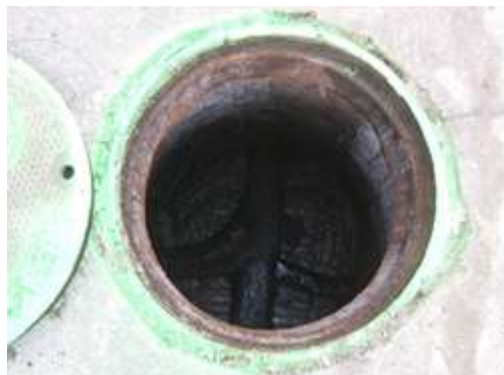
Miscellaneous

Condition: ☐ Sound ☒ **Cracked** ☐ Leaks

Frame View

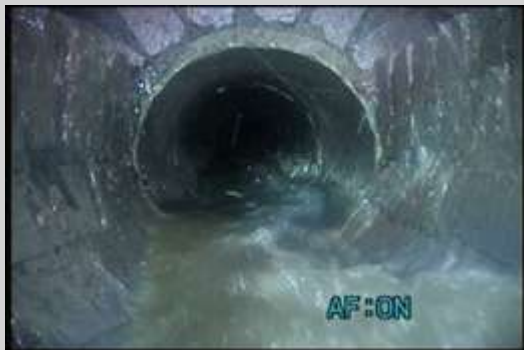
12 O'Clock Outflow

Pipe Height: **10.8** (in.) Rod and Bar (Angled)  
Pipe Material: **Clay** ☐ Pipe Lined  
Invert Depth: **9.70** (ft.) Flow Characteristics: **None**  
Deposits: ☒ None ☐ Mud ☐ Sludge ☐ Debris ☐ Grease  
Silt Depth: **0** (in.) Deposits Extent:  
Infiltration: **None** Pipe Seal Cond: **Sound**

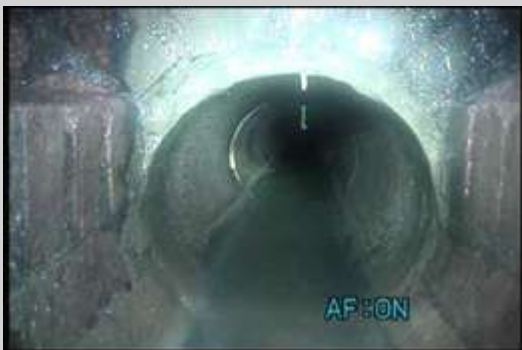
6 O'Clock Inflow

Pipe Height: **10.8** (in.) Rod and Bar (Angled)  
Pipe Material: **Clay** ☐ Pipe Lined  
Invert Depth: **9.42** (ft.) Flow Characteristics: **None**  
Deposits: ☒ None ☐ Mud ☐ Sludge ☐ Debris ☐ Grease  
Silt Depth: **0** (in.) Deposits Extent:  
Infiltration: **None** Pipe Seal Cond: **Sound**
